# **Amtrak Cascades 501 Derailment**

DuPont, Washington December 18, 2017

By Susan J. Dorey  
2018-9

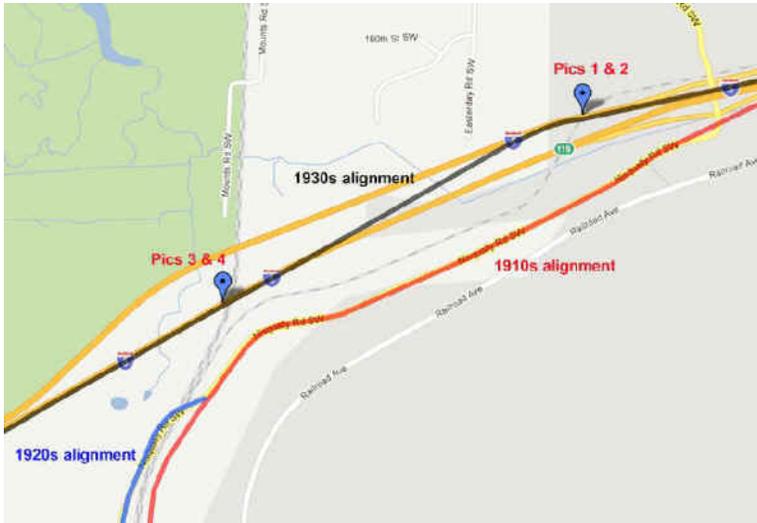
Fig. 3. 2011 map of alignments of U.S. 99, I-5, and the train tracks (dashed line) at DuPont

The derailment occurred at milepost 19.8 on the Lakewood subdivision.

It is the rail bridges over I-5 in DuPont that are central to the derailment. I-5 was constructed as a divided highway, with each direction over-crossed by one rail bridge. The west-most bridge, over the southbound I-5 lanes, was built in 1936 to cross U.S. 99; it is described as “Pony/through plate girder bridge.”
